The Home Detective

CONFIDENTIAL INSPECTION REPORT

16506 74th Avenue NE, Kenmore, Washington 98028

6/26/2010 9:00 am

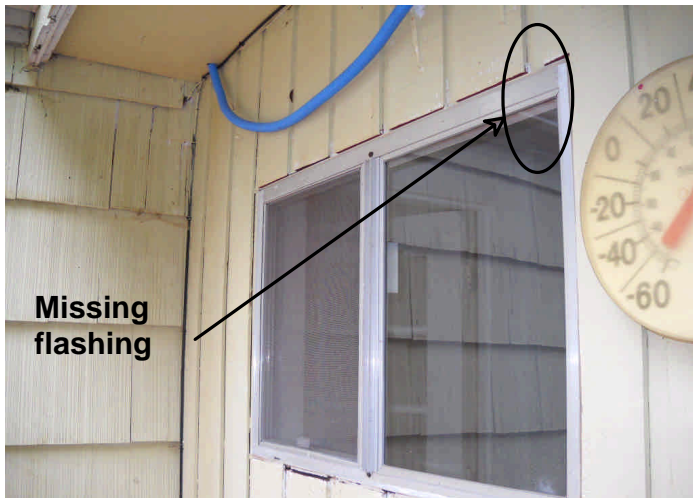
1.19 - Portions of the siding are not properly flashed. Proper flashing helps to ensure that rain drains away from the home, and does not intrude into the walls. Absent proper flashing, the exterior envelope is often dependent upon the application of appropriate caulking to help prevent moisture intrusion at wall penetrations such as windows and doors. We recommend regular monitoring of all wall penetrations, and correcting as appropriate, to help ensure that they are properly secured against moisture intrusion.

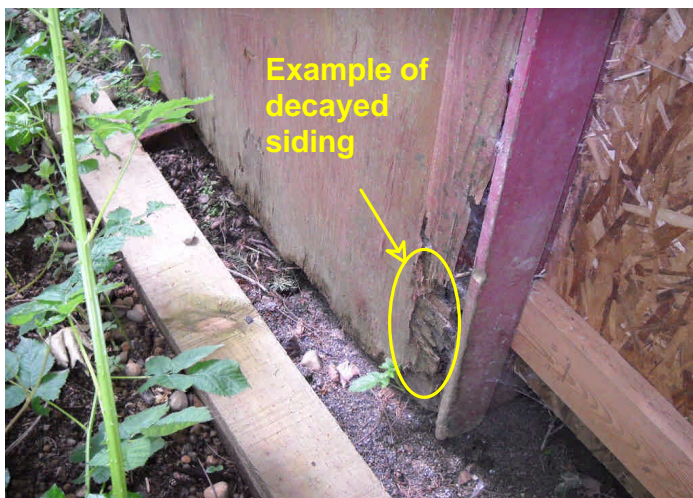
1.20 - Some portions of the siding are decay damaged. We recommend consulting an appropriately qualified contractor prior to closing to remove and replace the damaged components and restore the affected area(s) to as-new condition

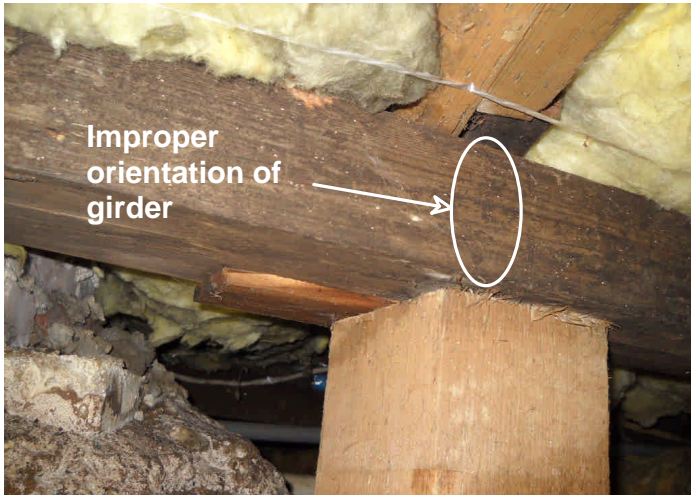
prevents a recurrence of this condition. Damaged components should be removed and replaced.
2.15 - Some support framing has been improperly installed. This reduces the ability of the framing to perform properly. It may be a factor in the uneven floors noted elsewhere in this report. We are unable to determine the full extent and consequences of this condition due to the limited access to the crawlspace as noted elsewhere in this report. You may wish to consult a structural engineer for a second opinion.

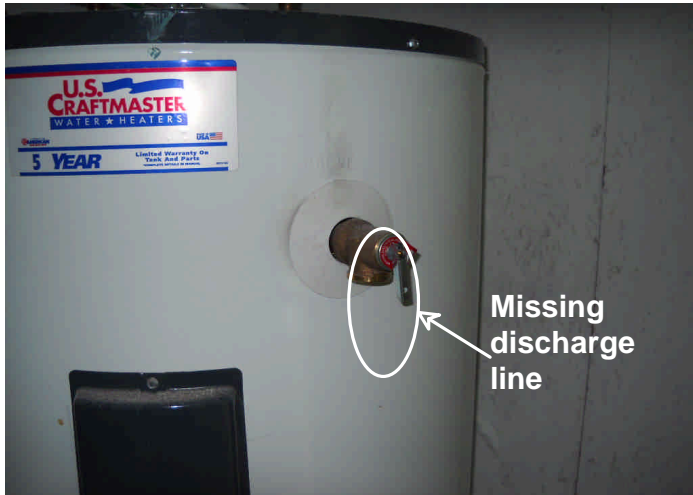
5.11 - The pressure relief valve on the water heater does not have a discharge pipe. This is a safety hazard. We recommend consulting a plumber prior to closing to install an appropriate discharge line that terminates in accordance with local standards

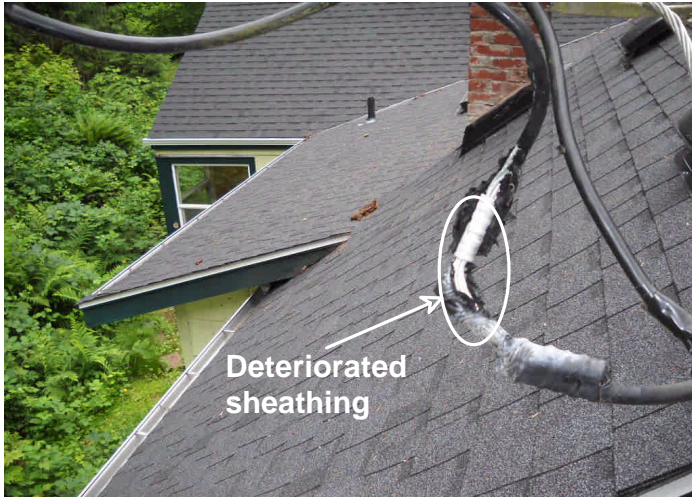
6.2 - There is deteriorated sheathing at the service cables. This is a safety hazard. This portion of the service cables is often the responsibility of the electric utility. We recommend consulting the utility prior to closing to correct as appropriate to eliminate the cable contact with the roof.

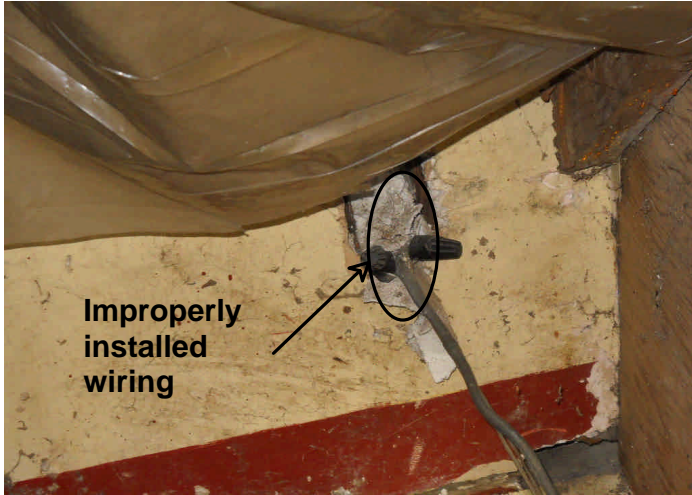
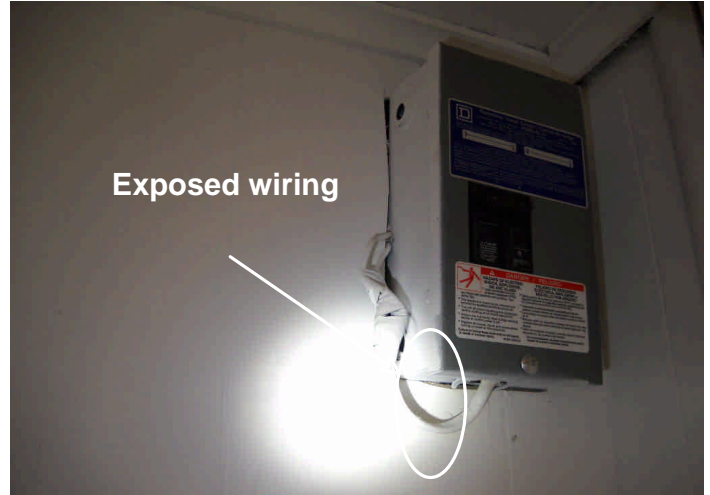
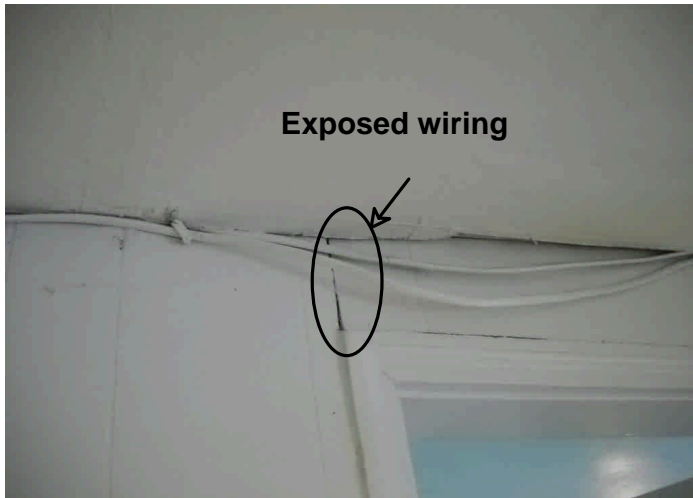
6.13 - There are junction boxes that lack appropriate cover plates. There is exposed wiring - both knob-and-tube, and Romex/sheathed. These are potential safety hazards. We recommend consulting an electrician prior to closing to correct as appropriate to ensure that all junction boxes have appropriate covers and that the wiring is installed in a safe manner.

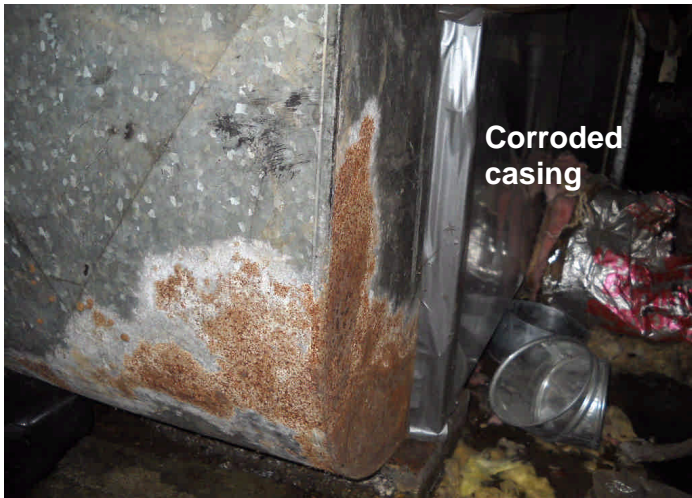
7.4 - The furnace plenum is corroded. This will affect the efficiency of the furnace, and may result in unhealthy air being distributed through the home. We recommend consulting an HVAC contractor prior to closing to correct as appropriate to locate and eliminate the condition(s) that led to the damage and restore the affected area(s) to as-new condition, and otherwise correct as appropriate so that the furnace is operating properly.

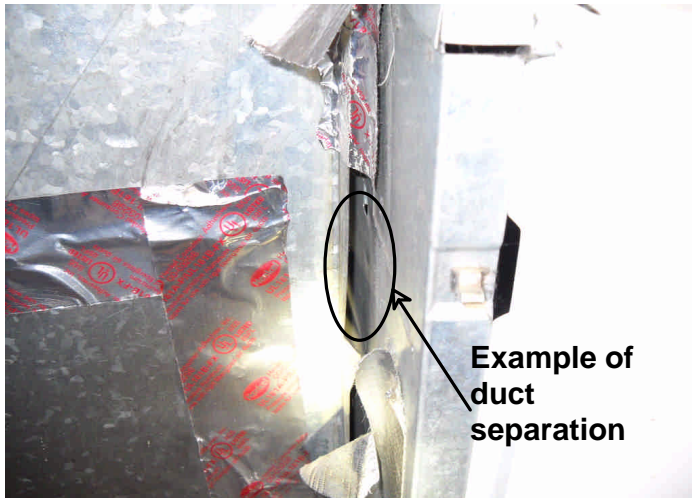
7.12 - There are disconnected ducts. Heat is being discharged into the crawlspace, rather than distributed through the home. We recommend consulting an HVAC contractor prior to closing to correct as appropriate to help ensure that the system is operating properly. We also recommend consulting a duct vacuuming service to vacuum the ducts to remove any debris or vermin that might have entered the system through the damaged duct

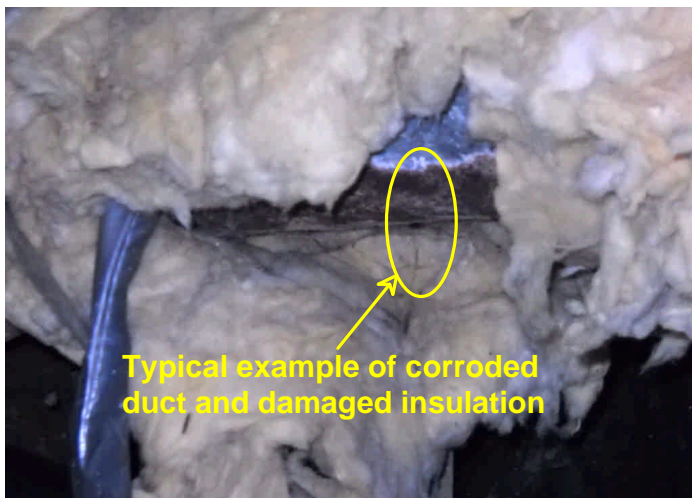
7.15 - The ducts are moisture damaged. There is corrosion visible on the ducts. This can result in an unhealthy air quality within the home. It can also contribute to higher energy expenses as air is lost through the damaged walls of the ducts. The corrosion will continue to progress. We recommend consulting an HVAC contractor to assess the situation, and correct as appropriate to eliminate the source of the corrosion, and ensure the system is operating safely and properly.

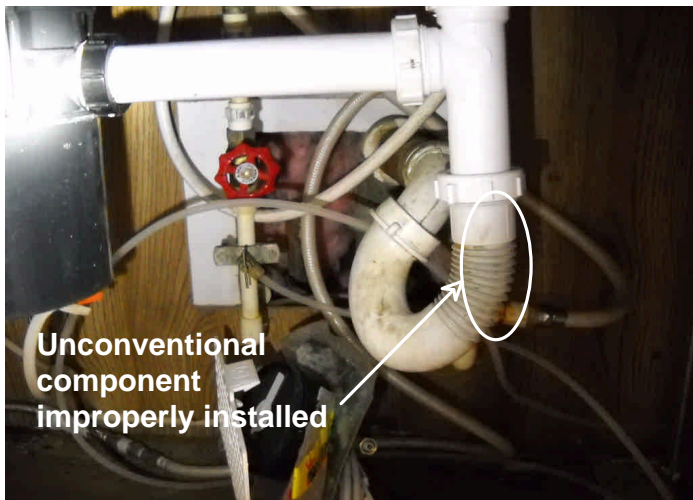
10.9 - The sink employs an unconventional flexible drainpipe that could contribute to blockages. The component is improperly installed. We recommend consulting a plumber to correct as appropriate prior to closing

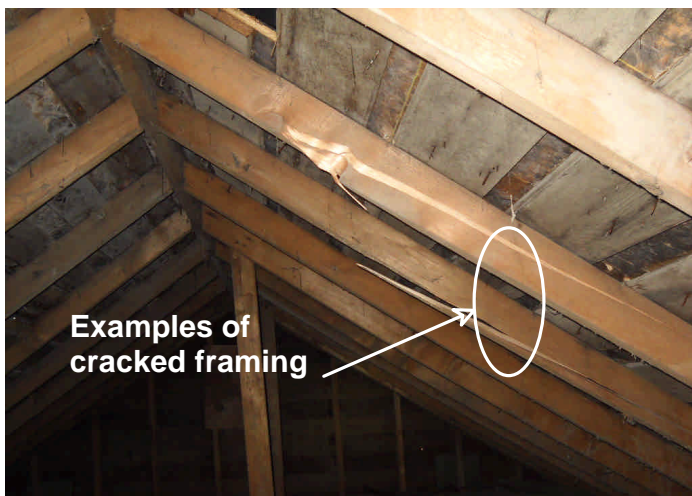
13.2 - There are cracked rafters. Repairs are needed. We recommend consulting an appropriately licensed and insured contractor prior to closing to correct as appropriate to restore the integrity of the framing system.

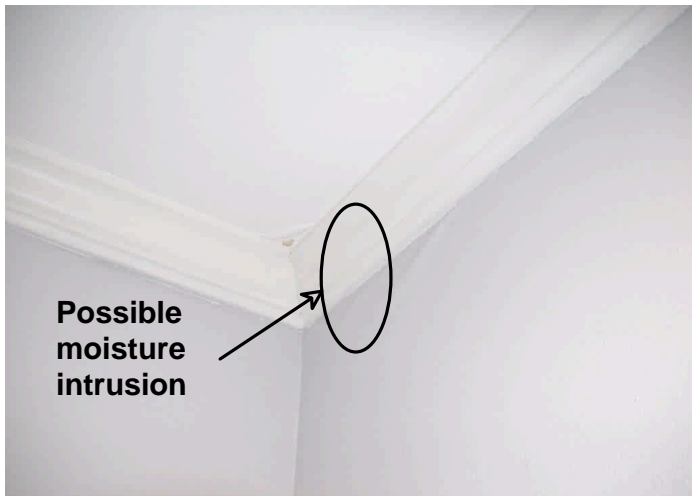
15.3 - The wall apperas to be moisture damaged. We recommend consulting an appropriately qualified contractor to locate and eliminate the source(s) of the moisture, remove and replace any damaged components, and restore the affected area(s) to as-new condition.
