The Home Detective

CONFIDENTIAL INSPECTION REPORT

16506 74th Avenue NE, Kenmore, Washington 98028

6/26/2010 9:00 am

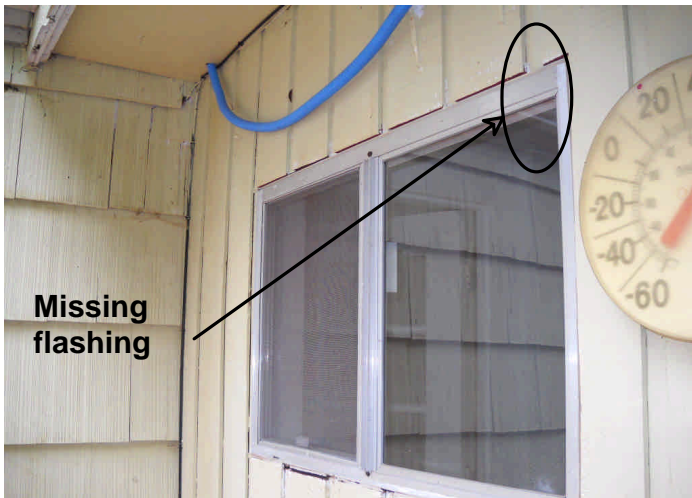
- 1.10 Portions of the siding are not properly flashed. Proper flashing helps to ensure that rain drains away from the home, and does not intrude into the walls. Absent proper flashing, the exterior envelope is often dependent upon the application of appropriate caulking to help prevent moisture intrusion at wall penetrations such as windows and doors. We recommend regular monitoring of all wall penetrations, and correcting as appropriate, to help ensure that they are properly secured against moisture intrusion.

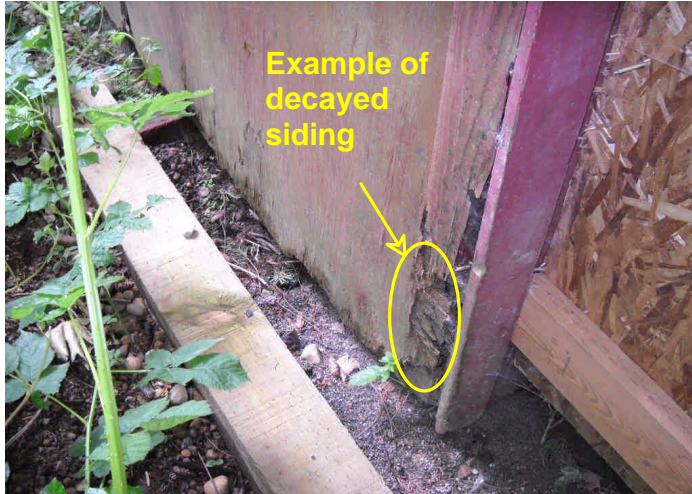
- 1.11 Some portions of the siding are decay damaged. We recommend consulting an appropriately qualified contractor prior to closing to remove and replace the damaged components and restore the affected area(s) to as-new condition

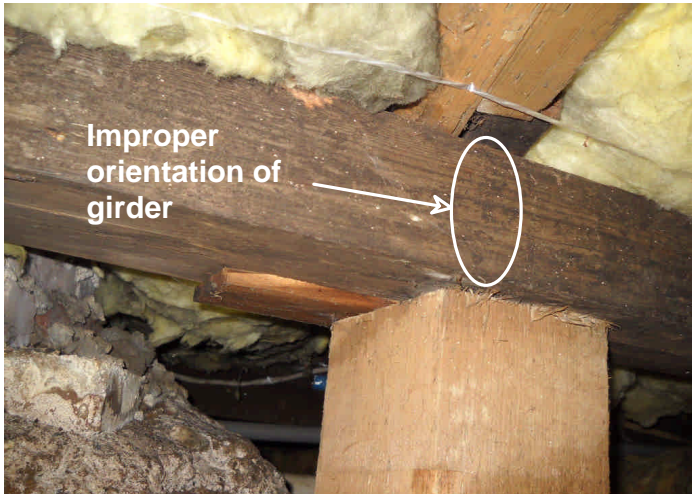
- 2.4 Portions of the floor framing are in contact with the soil. There is no damage visible. We recommend consulting an appropriately qualified contractor to eliminate the soil contact in a manner that prevents a recurrence of this condition. Damaged components should be removed and replaced.
- 2.5 Some support framing has been improperly installed. This reduces the ability of the framing to perform properly. It may be a factor in the uneven floors noted elsewhere in this report. We are unable to determine the full extent and consequences of this condition due to the limited access to the crawlspace as noted elsewhere in this report. You may wish to consult a structural engineer for a second opinion.

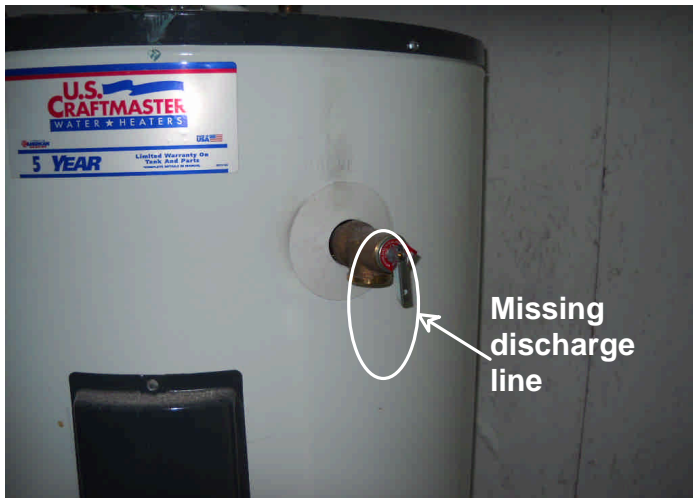
- 5.2 The pressure relief valve on the water heater does not have a discharge pipe. This is a safety hazard. We recommend consulting a plumber prior to closing to install an appropriate discharge line that terminates in accordance with local standards

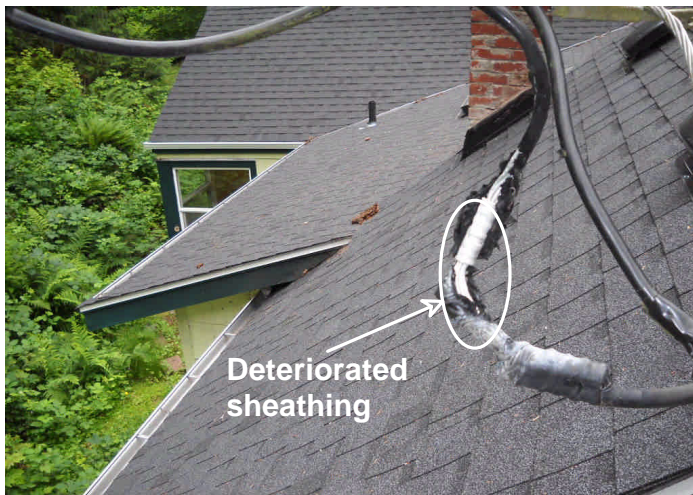
- 6.1 There is deteriorated sheathing at the service cables. This is a safety hazard. This portion of the service cables is often the responsibility of the electric utility. We recommend consulting the utility prior to closing to correct as appropriate to eliminate the cable contact with the roof.

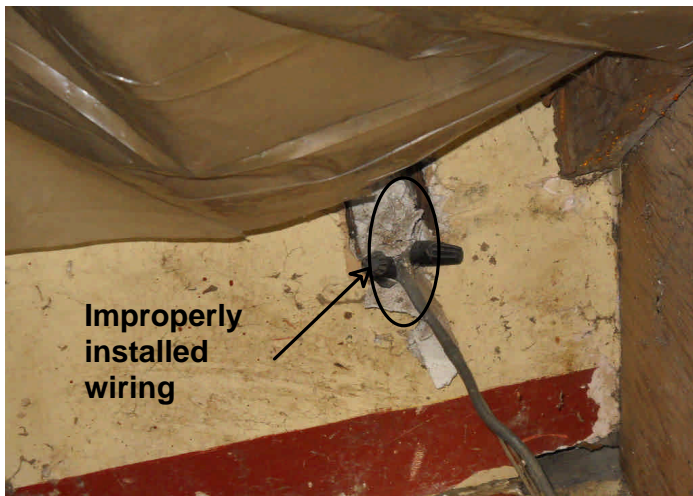
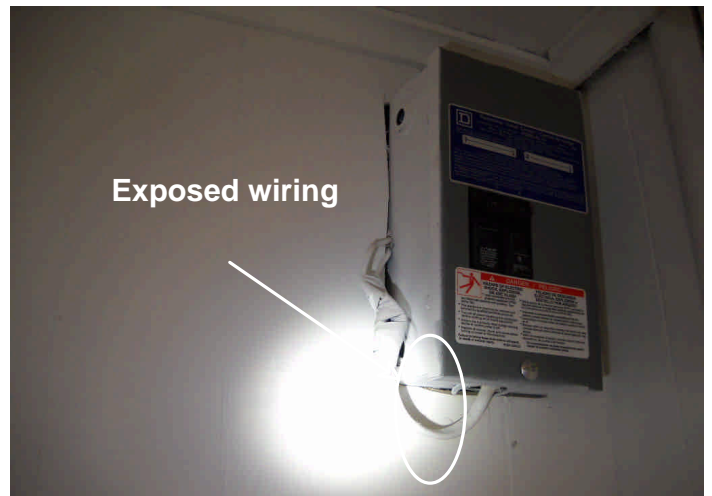
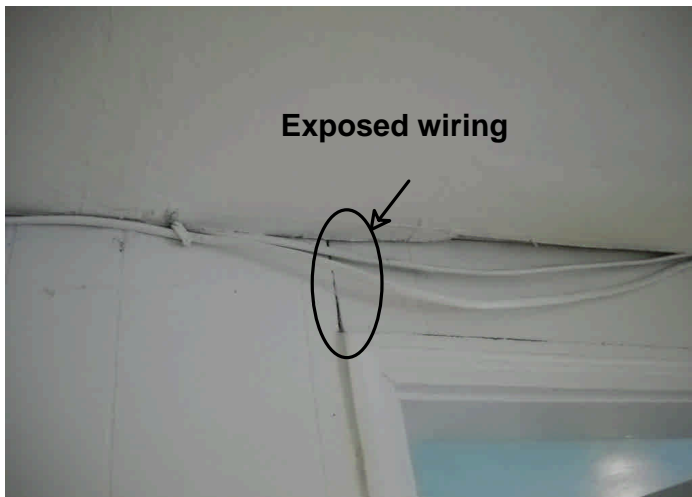
- 6.7 There are surface mounted electrical cables. This is a potential safety hazard. We recommend consulting an electrician to correct as appropriate to help eliminate this safety hazard
- 6.8 There are junction boxes that lack appropriate cover plates. There is exposed wiring - both knob-and-tube, and Romex/sheathed. These are potential safety hazards. We recommend consulting an electrician prior to closing to correct as appropriate to ensure that all junction boxes have appropriate covers and that the wiring is installed in a safe manner.

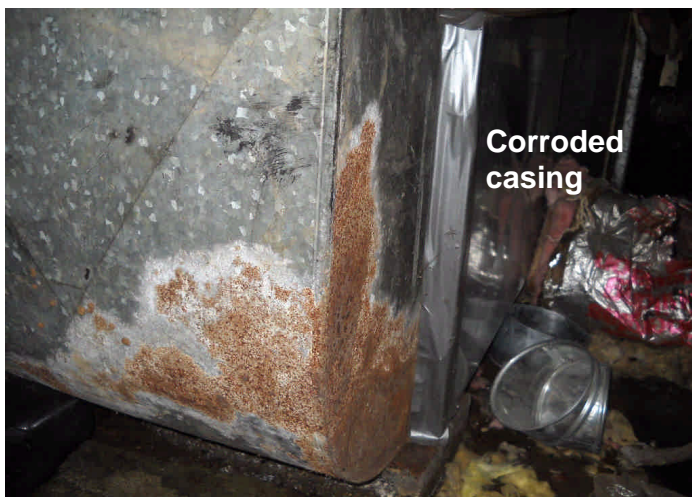
- 7.1 The furnace plenum is corroded. This will affect the efficiency of the furnace, and may result in unhealthy air being distributed through the home. We recommend consulting an HVAC contractor prior to closing to correct as appropriate to locate and eliminate the condition(s) that led to the damage and restore the affected area(s) to as-new condition, and otherwise correct as appropriate so that the furnace is operating properly.

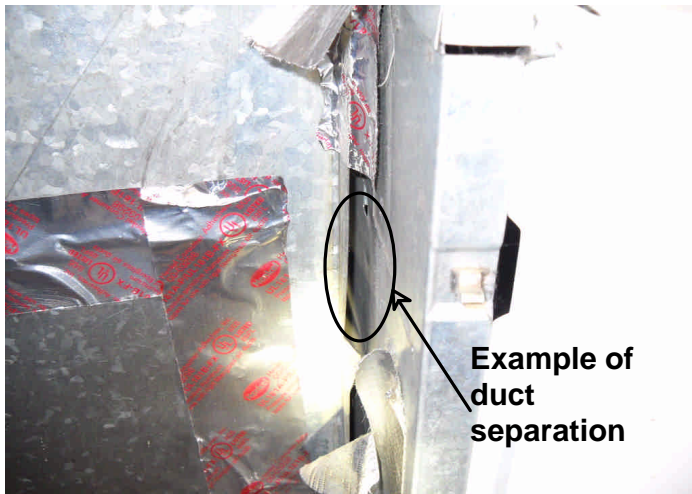
- 7.7 There are disconnected ducts. Heat is being discharged into the crawlspace, rather than distributed through the home. We recommend consulting an HVAC contractor prior to closing to correct as appropriate to help ensure that the system is operating properly. We also recommend consulting a duct vacuuming service to vacuum the ducts to remove any debris or vermin that might have entered the system through the damaged duct

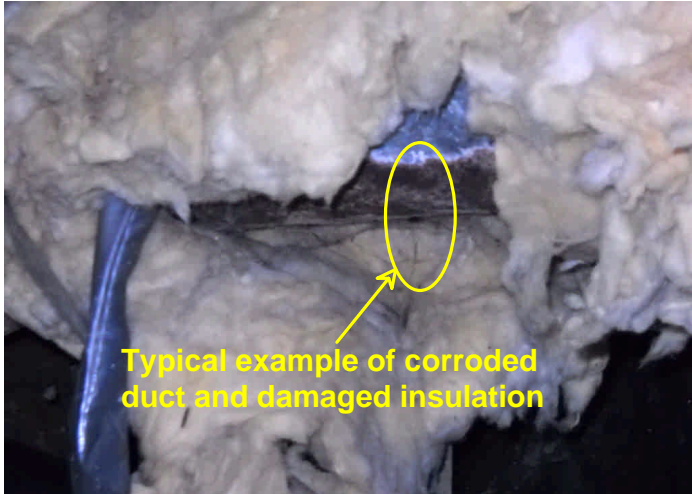
- 7.10 The ducts are moisture damaged. There is corrosion visible on the ducts. This can result in an unhealthy air quality within the home. It can also contribute to higher energy expenses as air is lost through the damaged walls of the ducts. The corrosion will continue to progress. We recommend consulting an HVAC contractor to assess the situation, and correct as appropriate to eliminate the source of the corrosion, and ensure the system is operating safely and properly.

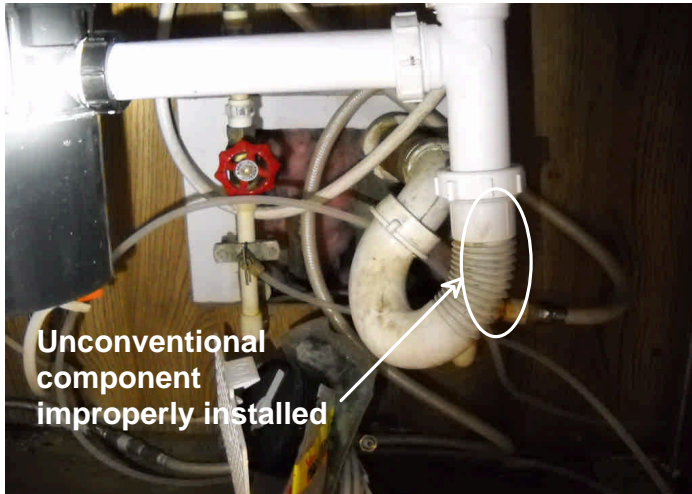
- 10.1 The sink employs an unconventional flexible drainpipe that could contribute to blockages. The component is improperly installed. We recommend consulting a plumber to correct as appropriate prior to closing

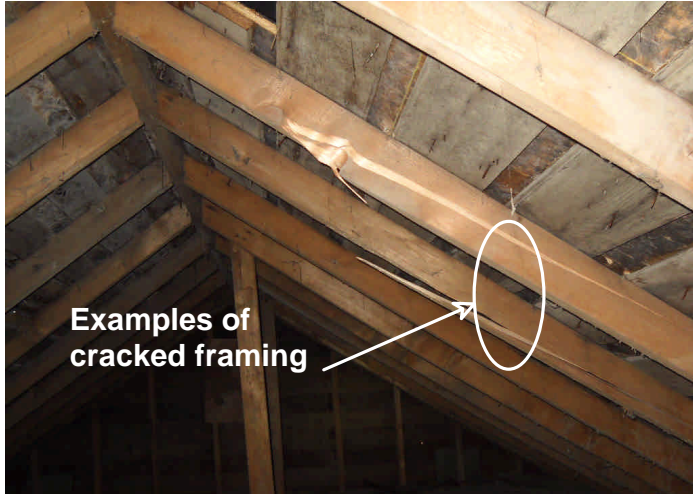
- 13.1 There is sagging sheathing. This is unusual. The cause is not obvious. We recommend consulting a roof contractor to assess the condition and correct as appropriate to restore and maintain the integrity of the roof framing and sheathing
- 13.2 There are cracked rafters. Repairs are needed. We recommend consulting an appropriately licensed and insured contractor prior to closing to correct as appropriate to restore the integrity of the framing system.

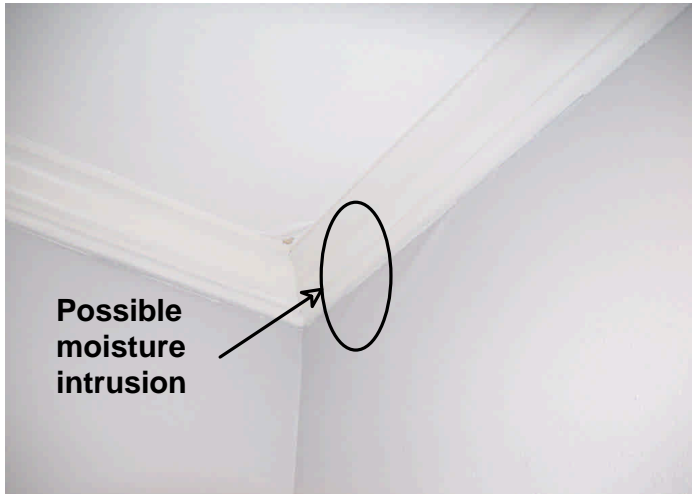
15.1 The wall appears to be moisture damaged. We recommend consulting an appropriately qualified contractor to locate and eliminate the source(s) of the moisture, remove and replace any damaged components, and restore the affected area(s) to as-new condition.
