The Home Detective

CONFIDENTIAL INSPECTION REPORT

Your New Address, Your New City, Washington

7/29/2009 9:00 am

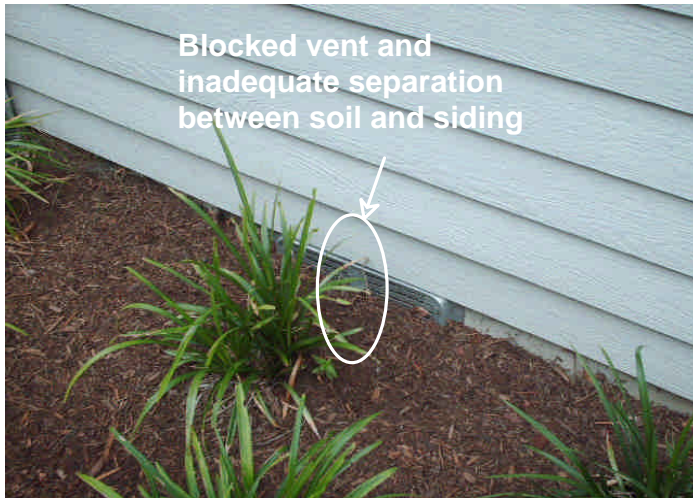
1.5 - There is inadequate vertical clearance between the siding and the finished grade. This creates a risk of insect and moisture decay damage to the home. There should be at least 6 inches vertical clearance between the finished grade and groundcover and the lower edge of the siding to help minimize this risk.

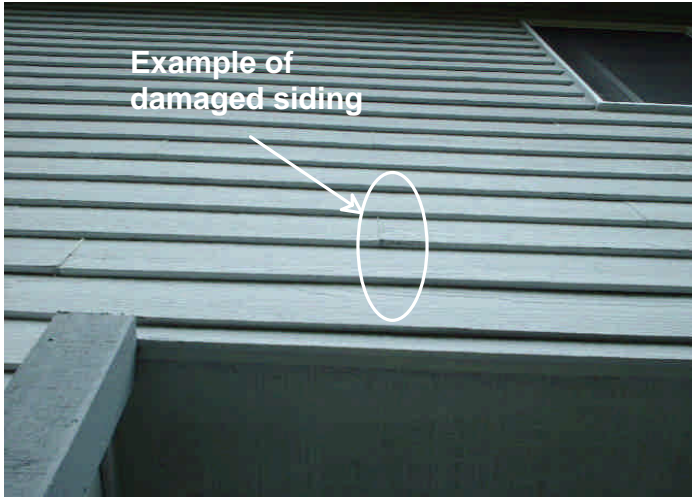
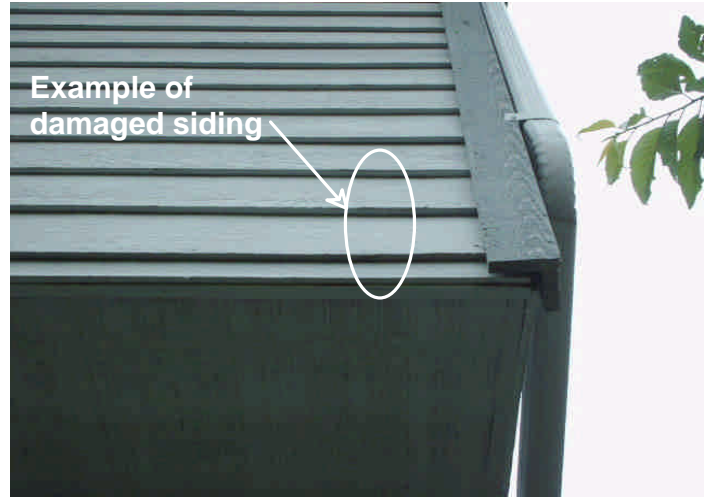
1.10 - There is damage to the oriented strand board siding. The siding is absorbing moisture. The material is deteriorating. This is not unusual with this type siding. The damage can not be reversed. The deterioration is progressive and will continue. The damage exists to varying degrees on all walls sheathed with this siding. We recommend removing and replacing the siding. This will help to reduce the risk of damage to the underlying wall framing and sheathing.

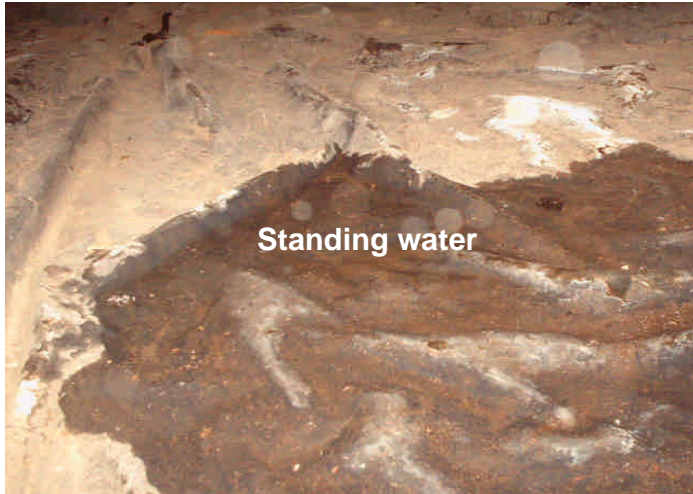
2.12 - There is standing water in the crawlspace. It may be a seasonal issue. We recommend consulting a drainage contractor to assess the condition. The source of the water should be located, and appropriate corrective measures taken to eliminate the source of the water or manage it in such a way as to help prevent compromising the integrity of the structure

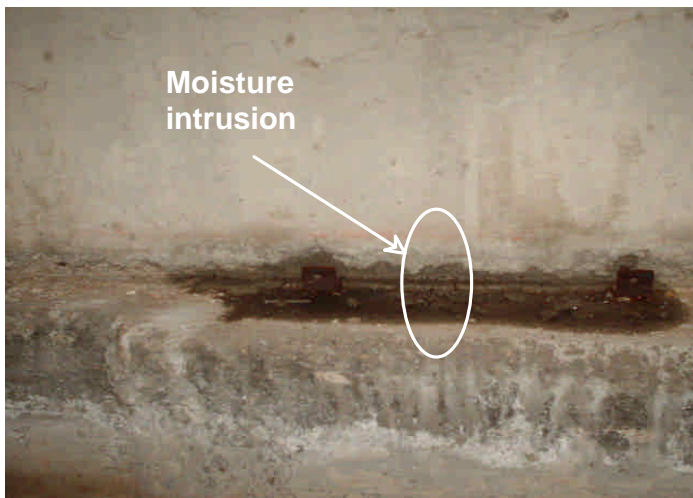
2.13 - There is evidence that moisture is migrating through the walls of the foundation. The moisture is intruding through gaps in the seam between the foundation wall and the footing. This is not unusual. We recommend sealing the gaps with an appropriate caulk or grout to help prevent further moisture intrusion.

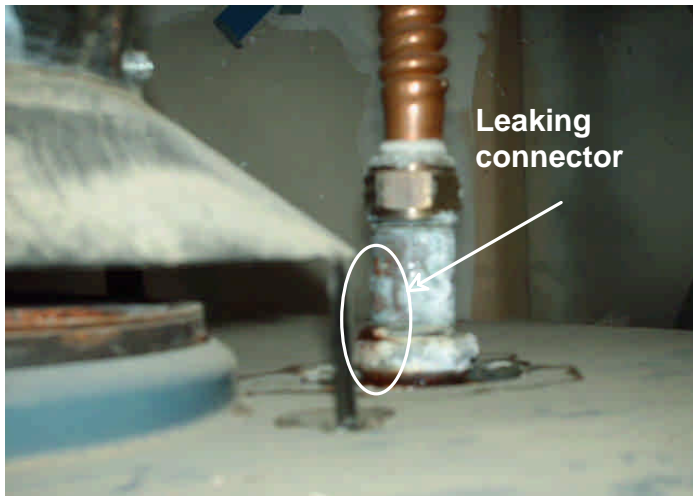
5.10 - The nipple at the water connector at the water heater is leaking. We recommend consulting a plumber to locate and eliminate the source of the leak and correct as appropriate to ensure the device functions properly
